RAILROAD COMMISSION OF TEXAS

RE: Weesatche Project, Goliad County
Uranium Exploration Permit No. 123C
Inspection Report

RAILROAD COMMISSION OF TEXAS SURFACE MINING AND RECLAMATION DIVISION URANIUM EXPLORATION INSPECTION REPORT

Project Name: Weesatche Permit Number: 123C
 Permittee: UEC County: Goliad
 Industry Representative(s) Present: James Gale
 Inspector: Steve Meadows Date of Inspection: July 30, 2009

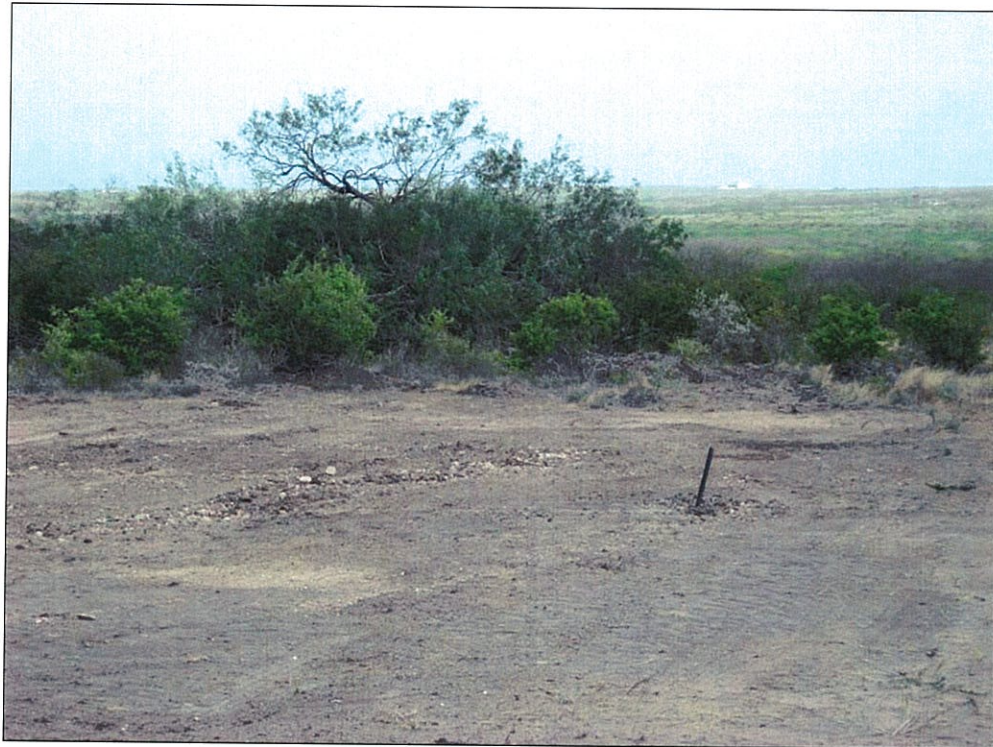
Photo 1: Site restoration at borehole LG-34 STMV Permit No. 140.

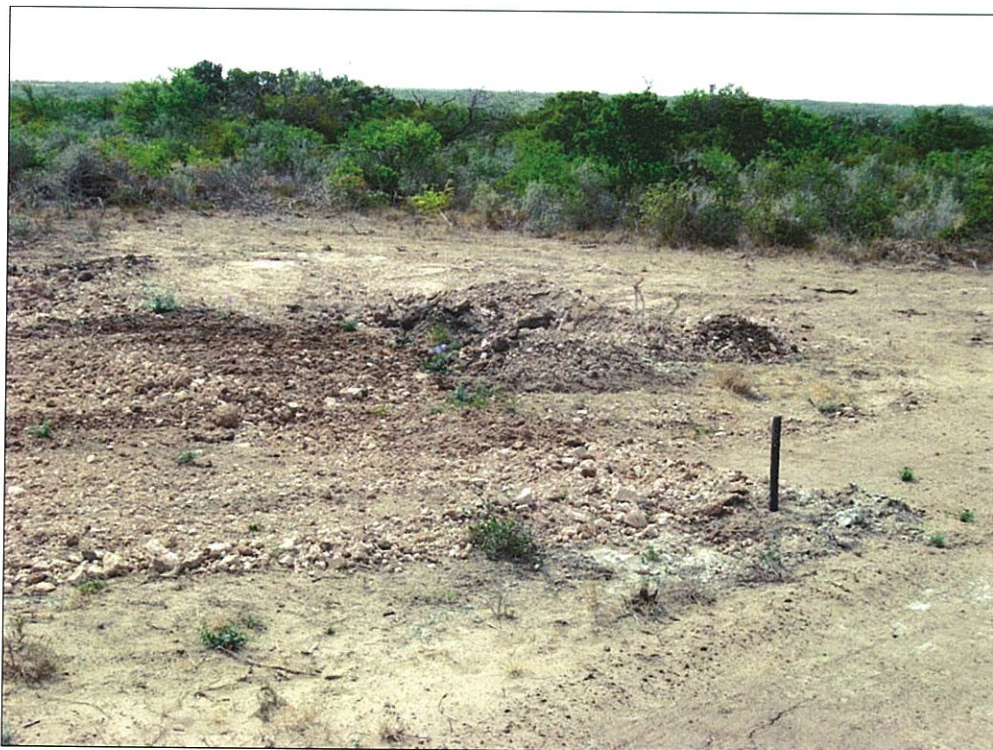
Photo 2: In progress site restoration at borehole LG-31.

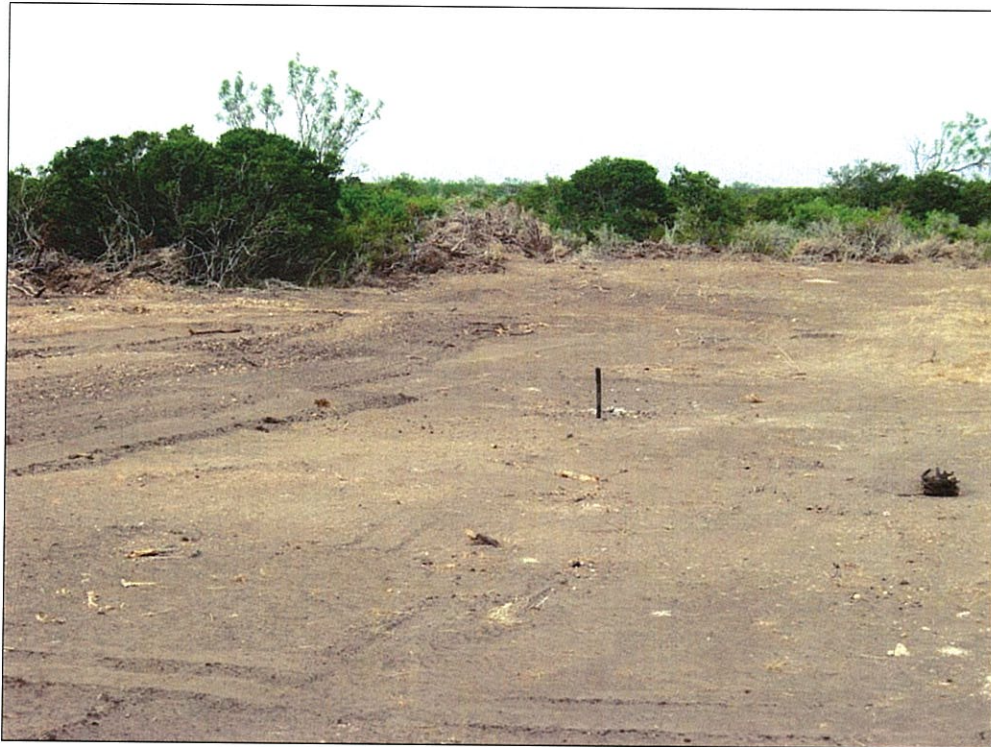
Photo 5: Site restoration at borehole LG-21

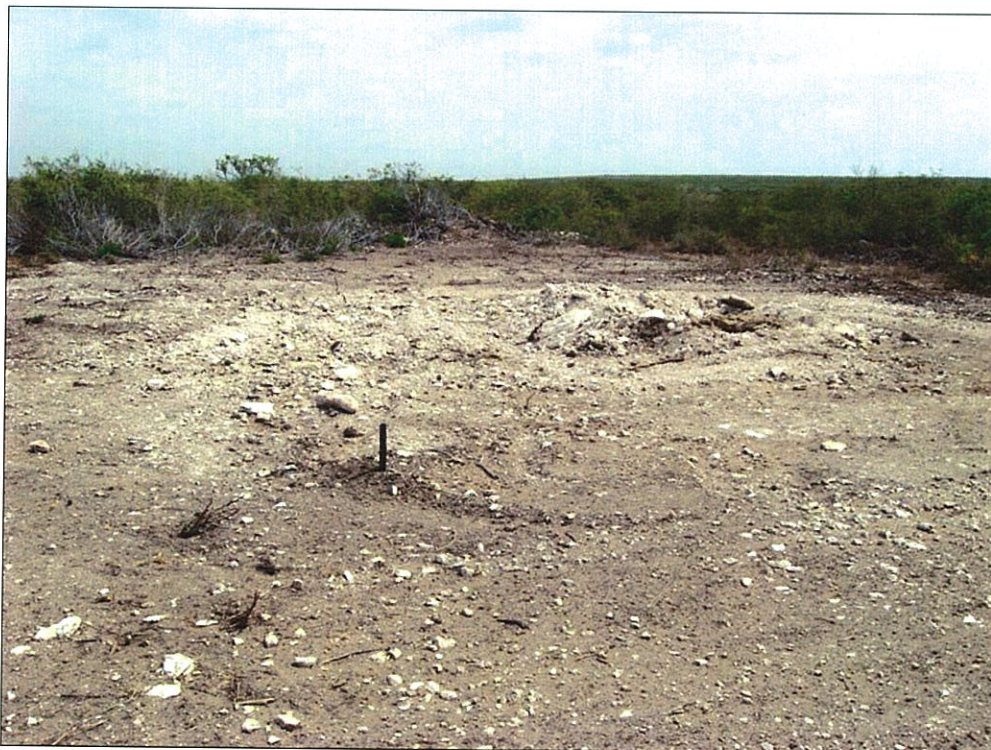
Photo 6: Drilling location of LG-42 with final restoration incomplete.

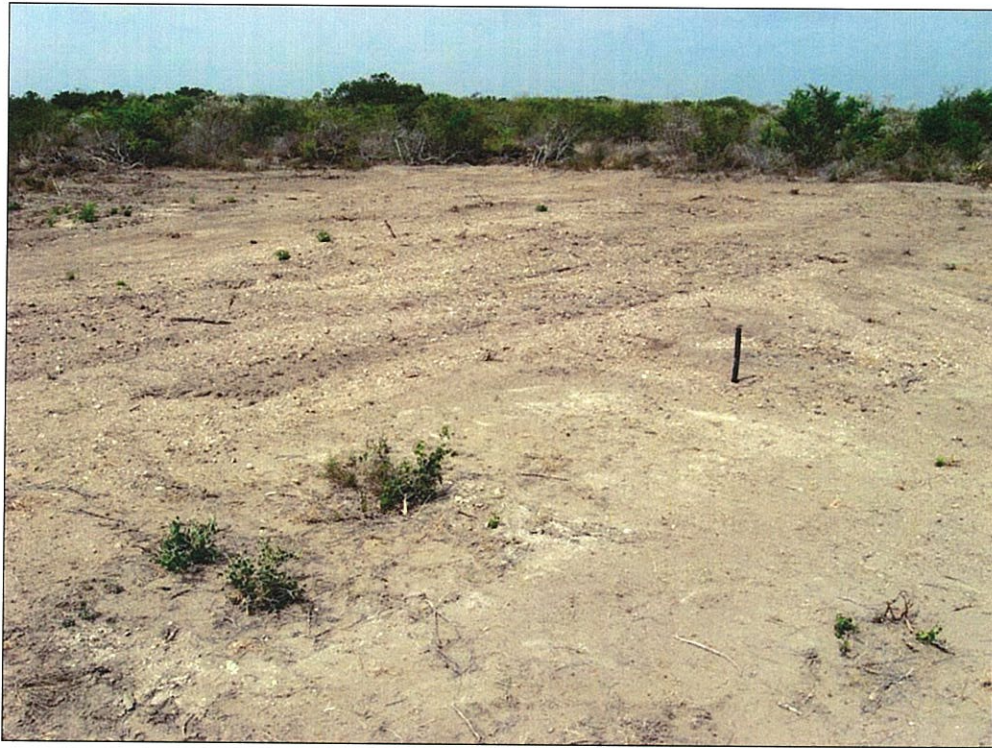
Photo 7: Drilling location of LG-41 with site restoration essentially complete.
